COMPACT, LIGHTWEIGHT, SMART BATTERY CHARGER

Final Report

Contract Line Item No. 0003

Contract No. W15P7T-04-C-K604

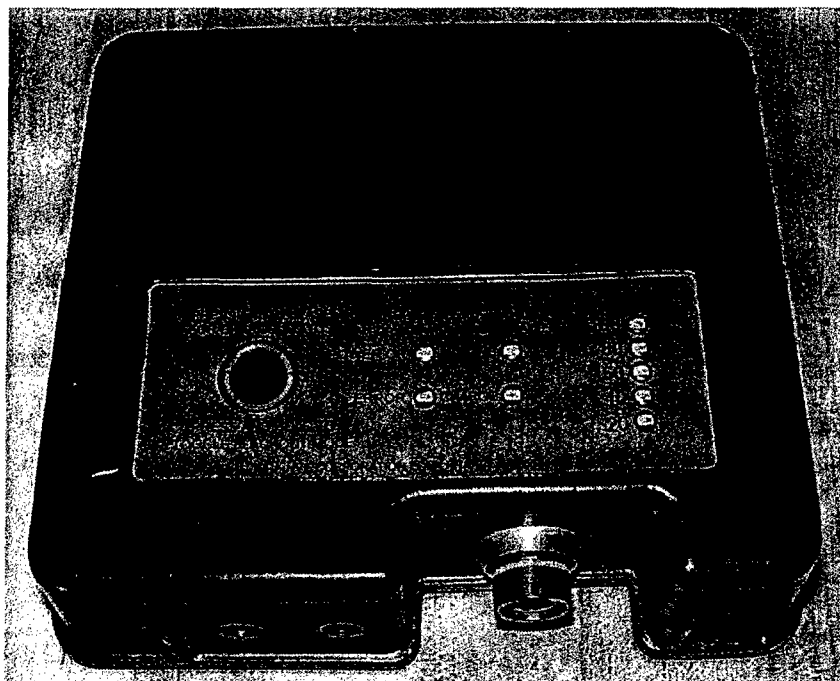
Figure 9. First-pass case design. This two-piece design holds the AC-DC converter's heat-sink against the inside wall of the case. The charger's PCB location utilizes a PCB-mounted bulkhead connector, rather than cable/wires between the PCB and the connector.

For the initial case design, an attempt was made to keep the form-factor of the case roughly the same as that of the LI-7 battery. With this design, the AC-DC converter heat-sink would be placed in thermal contact with one of the case's inside surfaces. The charger's PCB was placed next to the AC-DC converter, with a PCB-mounted bulkhead connector, for the daisy-chain function, helping to position the PCB and mount it to the case. In order to allow the unit to be serviced, and to simplify the case design and tooling, a screw-together design was used – rather than an ultrasonically welded design. Figure 9 shows an SLA model of the initial case design. The input and output cables have not been attached in this picture, but the rest of the charger has been assembled.
